# CG FLOORING SYSTEMS LTD

## Good Floor Repairs Steel The Day

**Client:** Aalco, Halesowen, UK  
**CG Flooring Systems**  
**Solution:** Joint repairs & 10mm fast track pumped cementitious screed.

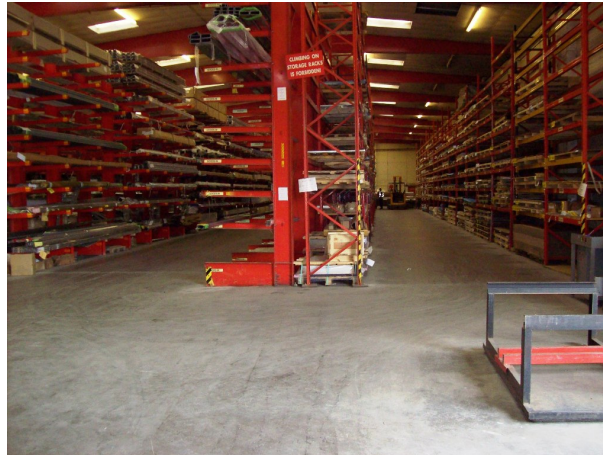
It was discovered during the initial slab repairs that the concrete slab was not thick

enough or strong enough to meet the client's future operating requirements. The typical thickness is 150mm, however, the floor was only 75mm in the areas that required repair and this was not suitable for sustaining heavy MHE traffic, particularly over the floor joints.

CGFS submitted a proposal to affect a proper repair. Core samples were taken around the area to determine the slab depth at which 3 problematic areas were identified. CGFS's new proposal was accepted by all and this allowed the work to be completed with

Aalco contacted CGFS with their flooring brief which required an initial survey. The recommendation by CGFS was for slab and joint repairs, to be followed by the installation of a 10mm fast track cementitious pump screed for the warehouse flooring area.
